## **Newlyn Ice Works – Initial Structural Condition Report**

Job number – 1214

Date	Revision	Comments
14 March 2022	/	First issue
15 February 2024	A	Update following site visit 2/2/2024

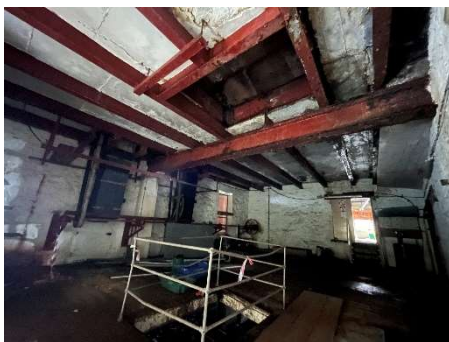
The east end of the second floor is concrete overlying downstand steel or wrought iron beams. The condition of the floor is not clear: the steelwork has some corrosion but a more intrusive investigation would be necessary to establish whether there is sufficient residual strength in the steel to be acceptable for a new use. However there is no indication that the floor is in real structural distress at present. There is a small cantilevered extension to the southeast corner of the building which should be assumed to be unstable until proven otherwise.

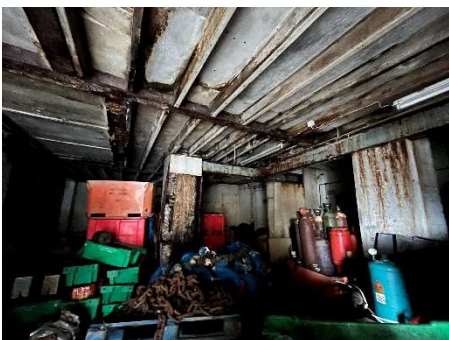
The west end of the first floor is in rather poor condition. It is extremely wet, potentially as a result of the enormous amount of water which remains in the building even though its industrial use ceased over a decade ago. The steel beams which support the timber floor appear to be heavily corroded. The residual section may prove sufficient to support a new use, however this will need to be carefully assessed at the next stage. One column in the space is very heavily corroded and this

may be indicative of corrosion elsewhere. The timber joists are heavily water damaged, though again they may have sufficient residual strength to be reused.

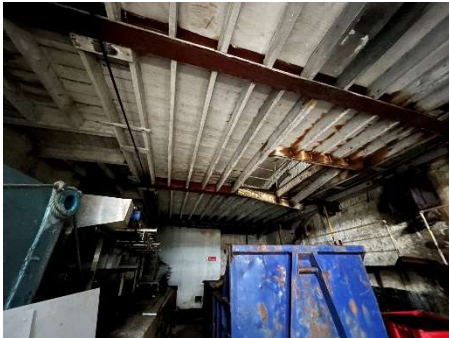
The east end of the first floor appears to be in better condition. Again the structure is steel or wrought iron beams supporting timber joists but the use in this space appears to have been much drier so the steelwork and the joists are not heavily corroded and water stained as they are elsewhere.

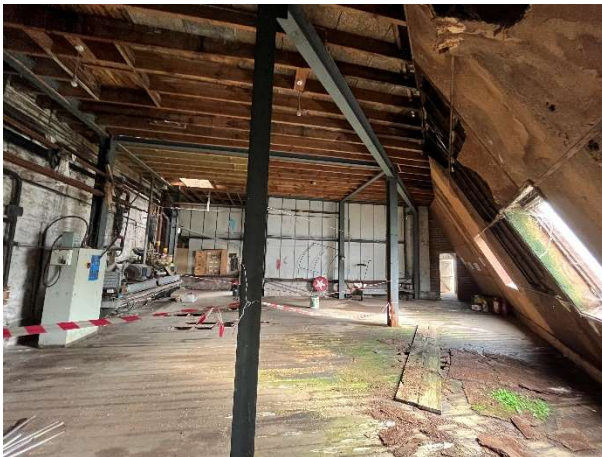
The roof structure generally appears to be in reasonable condition and is believed to have been renewed, possibly in the late 1980s. There are local holes in the flat roof which have allowed water in. The sloping roof to the southern building shows signs of water damage and would need to be very carefully checked if it is to be kept.

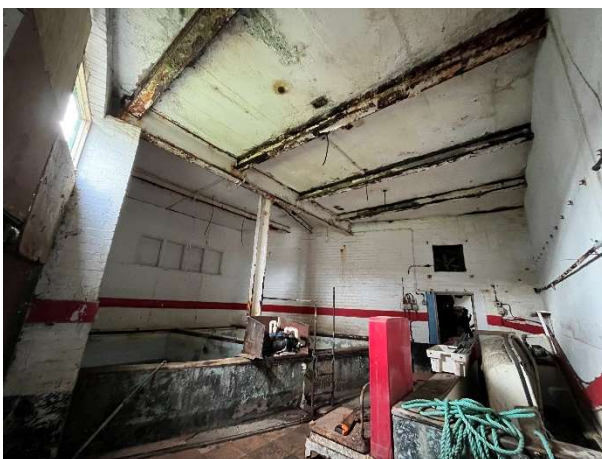
The first floor has some very obvious holes where water has come in through the flat roof. The main steel frame supporting the floor, however, appears to be in good condition so renewal of floor joists locally is all that would be required. Elsewhere the older parts of the first floor appear to be concrete filler joist or concrete spanning between downstand steels. Generally these areas are in much worse condition and their structural integrity would need to be carefully checked at the next stage.

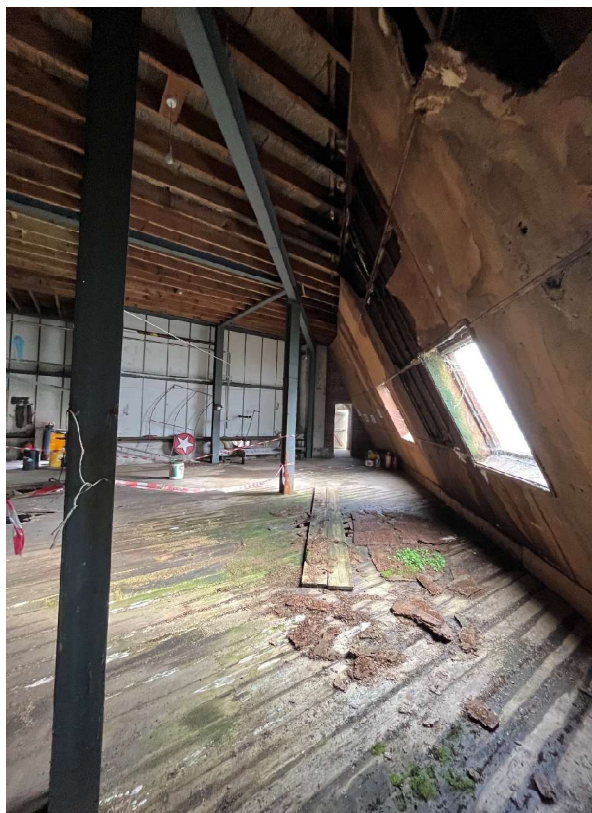
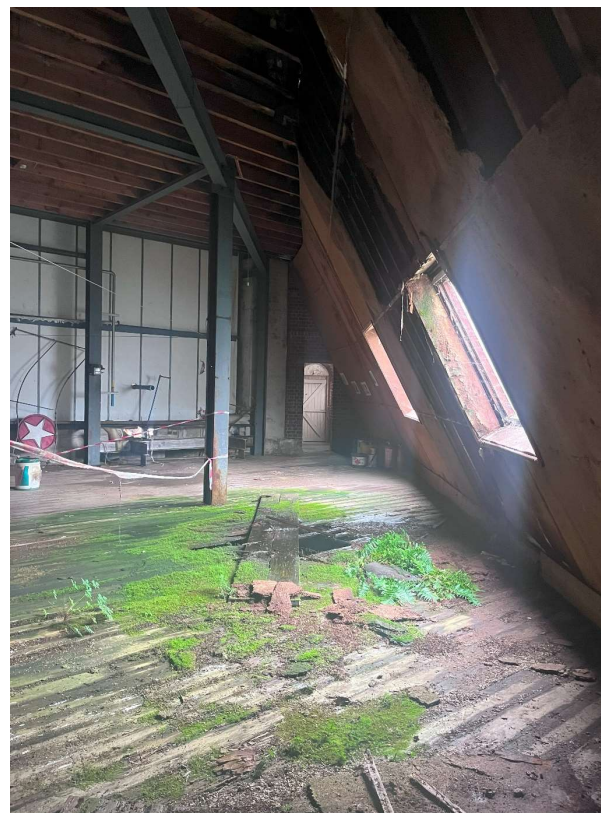
The southern section is starting to more rapidly deteriorate now. The hole in the main roof has enlarged and the timber first floor structure below should not be walked on.

At present the steel frame appears to be in tact still, and there is enough of the timber first floor and roof structure in tact to provide restraint to the external masonry walls. If the deterioration continues, however, eventually the mansard roof will become unstable and start to impact the walls. This also has safety implications for the adjacent public space, so work must be done to at least provide temporary roof repairs within the next 12 months.

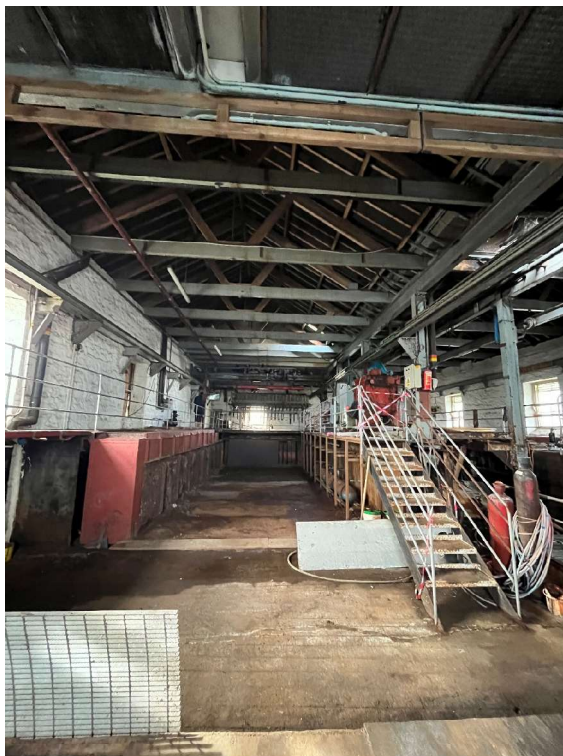
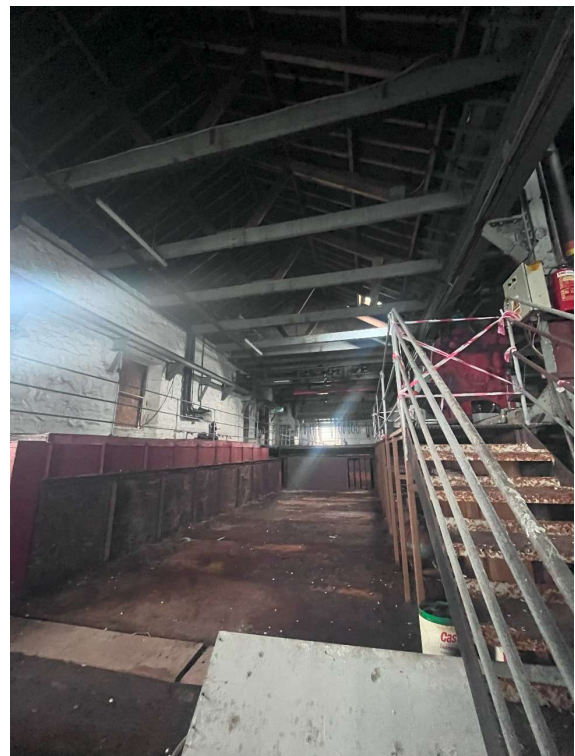
The northern section of the building is inherently significantly more robust than the southern, however it appears to be reaching the point where deterioration will accelerate. There is a significant hole in the valley gutter at the eastern end of the roof and water is pouring through that hole onto the floor structures below.

The major issue with this is a practical one – at present most of the floors in this building are good enough to walk on, which means that people can access the building and repair works could be carried out relatively easily. If repairs are not undertaken soon, however, the building will become unsafe to enter, either because floors cannot be walked on or because there is a danger of falling structure from above. There should, therefore, be a sense of urgency around carrying out repairs to the roof so that the building is allowed to dry out.

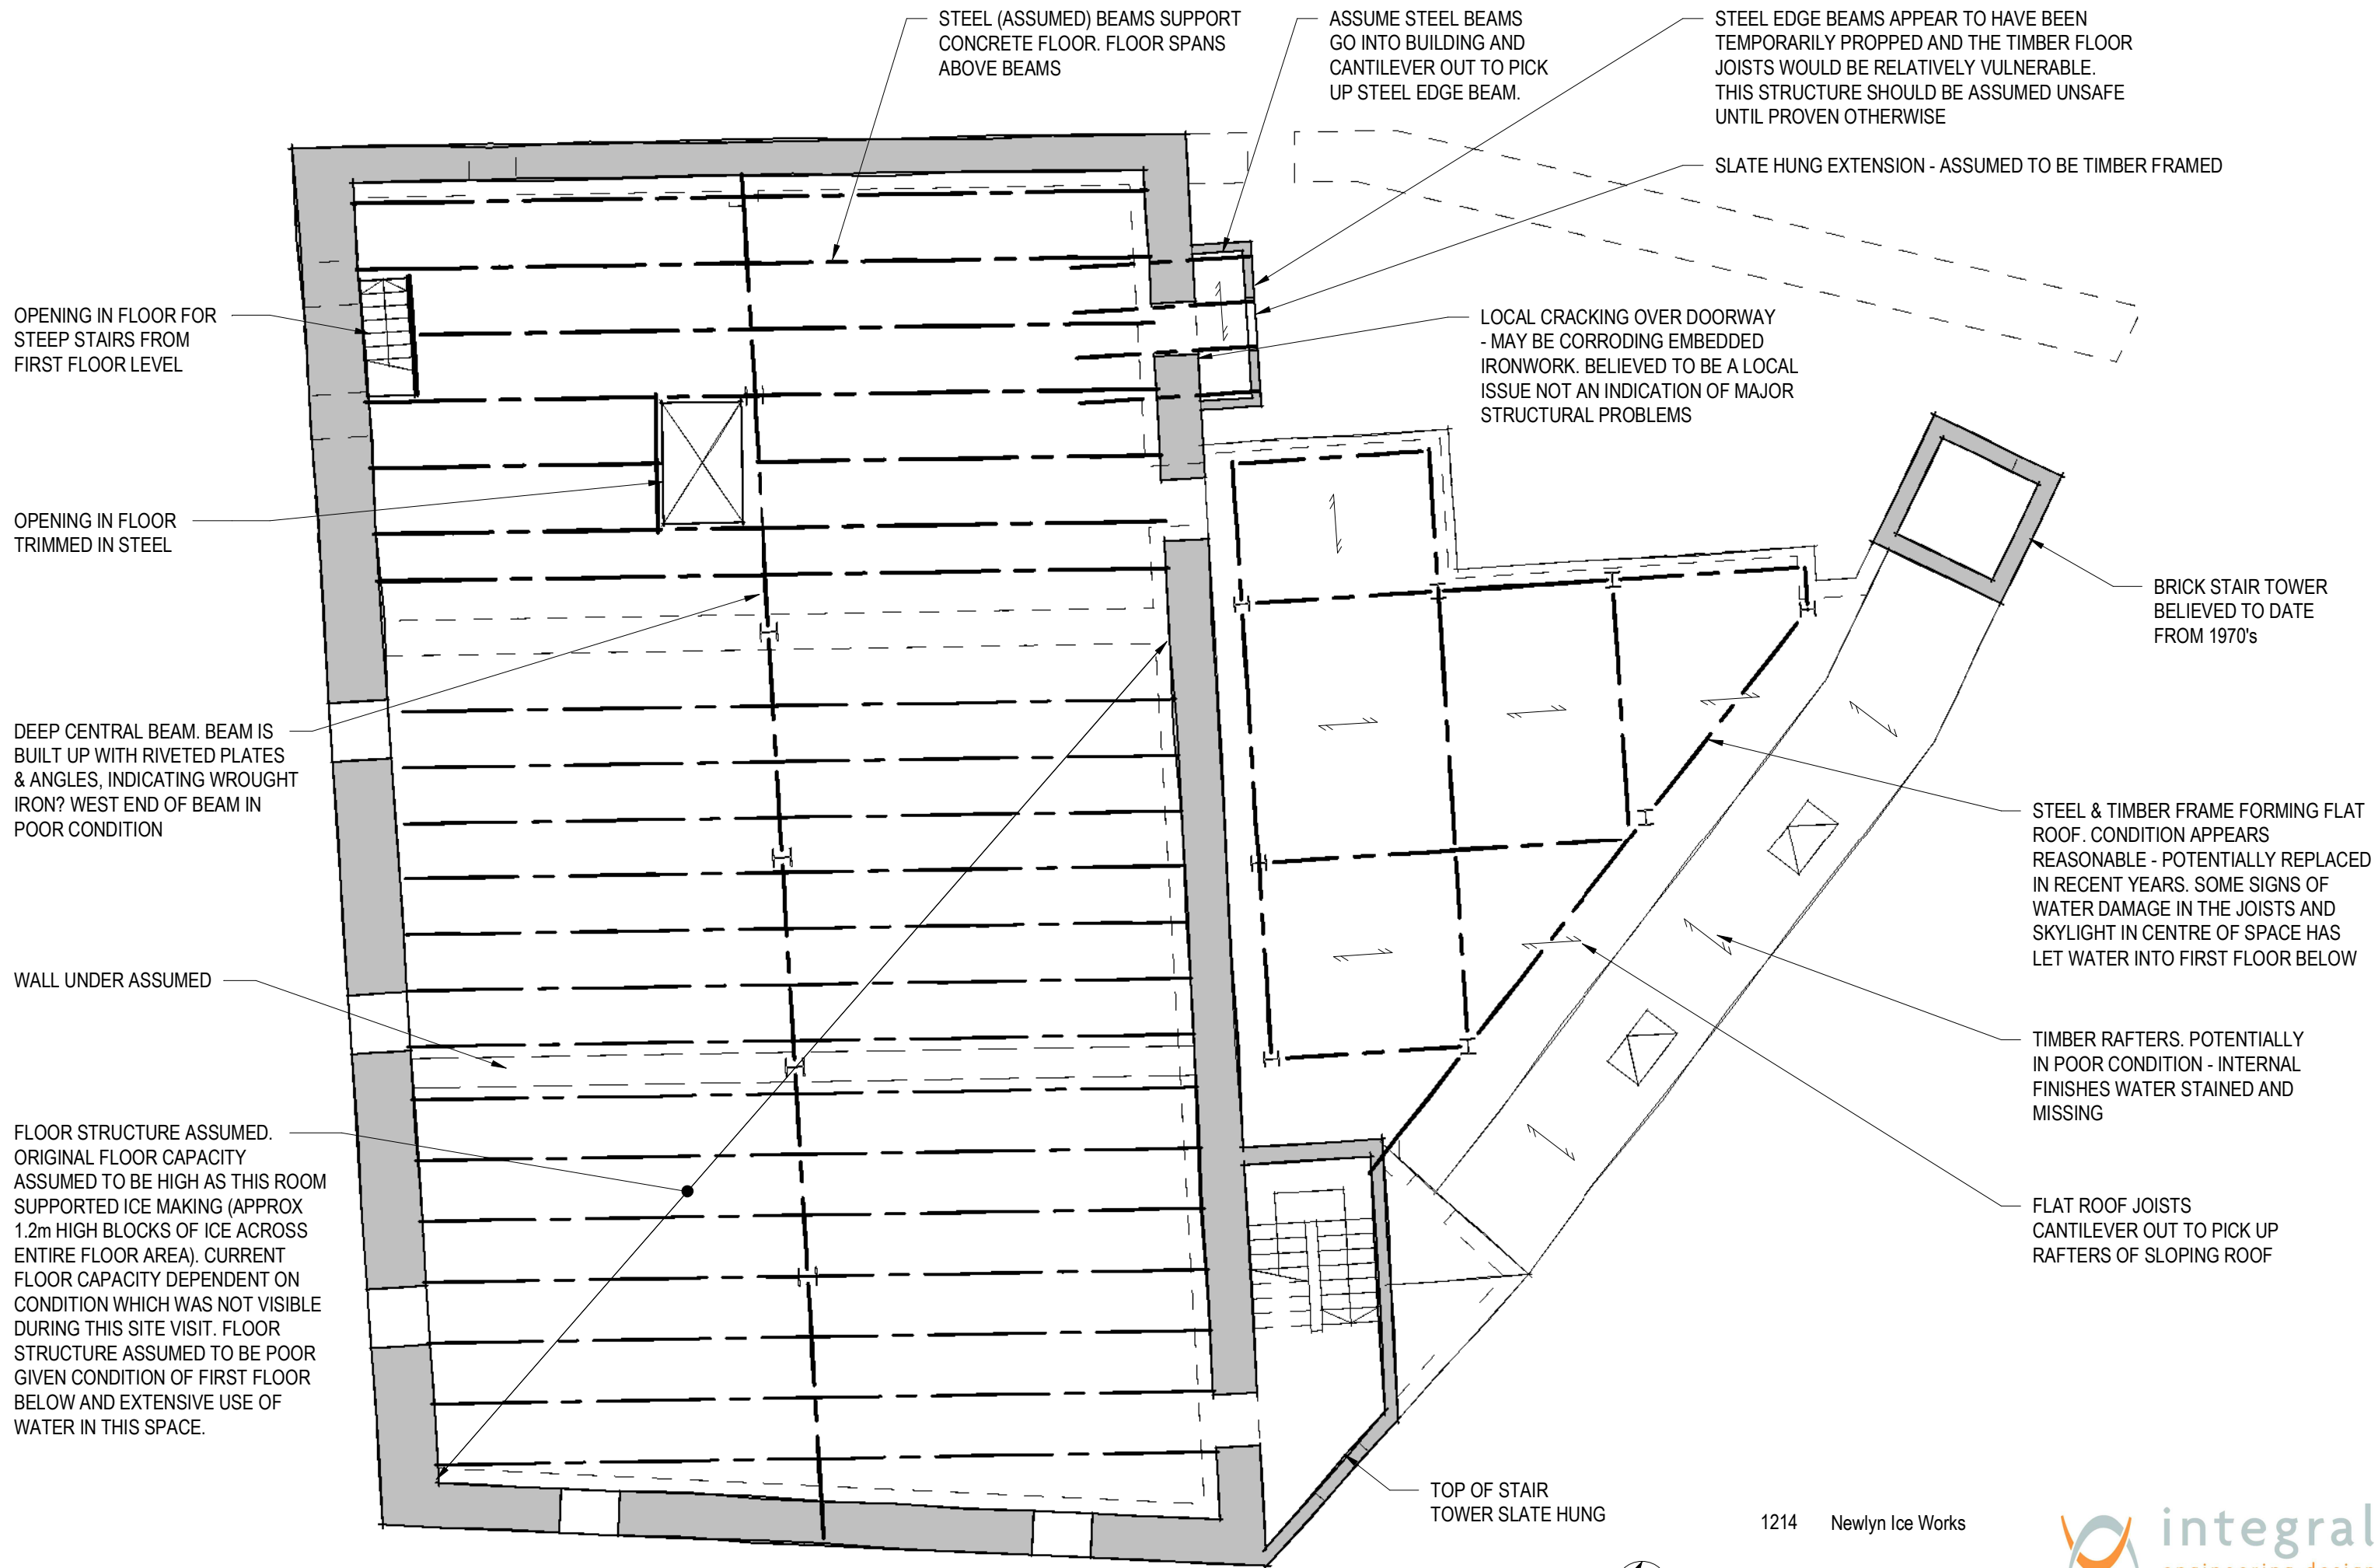
SK003  
G.A. Second Floor

STEEL EDGE BEAMS APPEAR TO HAVE BEEN TEMPORARILY PROPPED AND THE TIMBER FLOOR JOISTS WOULD BE RELATIVELY VULNERABLE. THIS STRUCTURE SHOULD BE ASSUMED UNSAFE UNTIL PROVEN OTHERWISE

LOCAL CRACKING OVER DOORWAY - MAY BE CORRODING EMBEDDED IRONWORK. BELIEVED TO BE A LOCAL ISSUE NOT AN INDICATION OF MAJOR STRUCTURAL PROBLEMS

DEEP CENTRAL BEAM. BEAM IS BUILT UP WITH RIVETED PLATES & ANGLES, INDICATING WROUGHT IRON? WEST END OF BEAM IN POOR CONDITION

STEEL & TIMBER FRAME FORMING FLAT ROOF. CONDITION APPEARS REASONABLE - POTENTIALLY REPLACED IN RECENT YEARS. SOME SIGNS OF WATER DAMAGE IN THE JOISTS AND SKYLIGHT IN CENTRE OF SPACE HAS LET WATER INTO FIRST FLOOR BELOW

TIMBER RAFTERS. POTENTIALLY IN POOR CONDITION - INTERNAL FINISHES WATER STAINED AND MISSING

FLOOR STRUCTURE ASSUMED. ORIGINAL FLOOR CAPACITY ASSUMED TO BE HIGH AS THIS ROOM SUPPORTED ICE MAKING (APPROX 1.2m HIGH BLOCKS OF ICE ACROSS ENTIRE FLOOR AREA). CURRENT FLOOR CAPACITY DEPENDENT ON CONDITION WHICH WAS NOT VISIBLE DURING THIS SITE VISIT. FLOOR STRUCTURE ASSUMED TO BE POOR GIVEN CONDITION OF FIRST FLOOR BELOW AND EXTENSIVE USE OF WATER IN THIS SPACE.
