## **Newlyn Ice Works – Initial Structural Condition Report**

Job number – 1214

Date	Revision	Comments
14 March 2022	/	First issue
15 February 2024	A	Update following site visit 2/2/2024

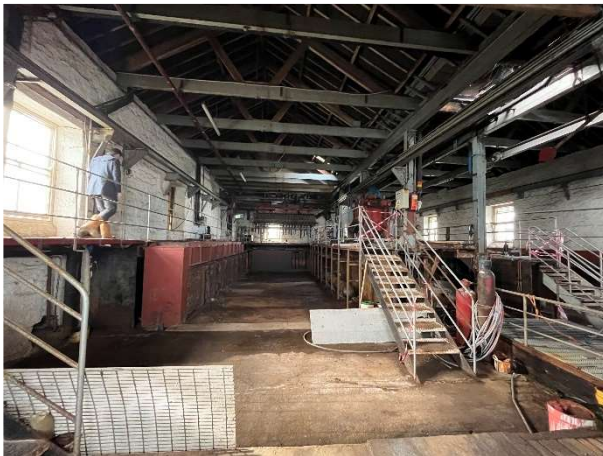
Second floor level showing roof structure

The roof structures appear generally to be in good condition and we are told that it was rebuilt in the 1970s.

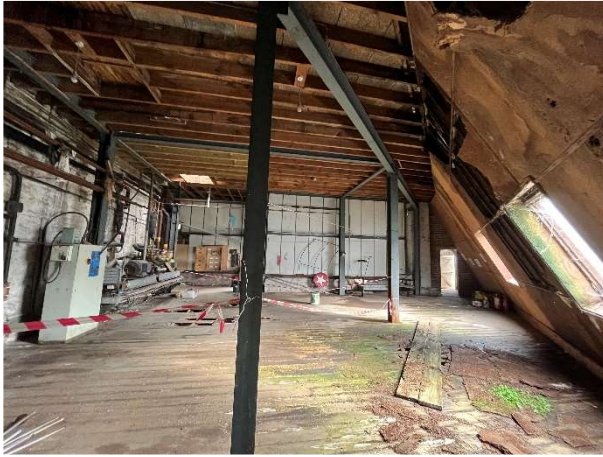
First floor level showing roof structure

The roof structure generally appears to be in reasonable condition and is believed to have been renewed, possibly in the late 1980s. There are local holes in the flat roof which have allowed water in. The sloping roof to the southern building shows signs of water damage and would need to be very carefully checked if it is to be kept.

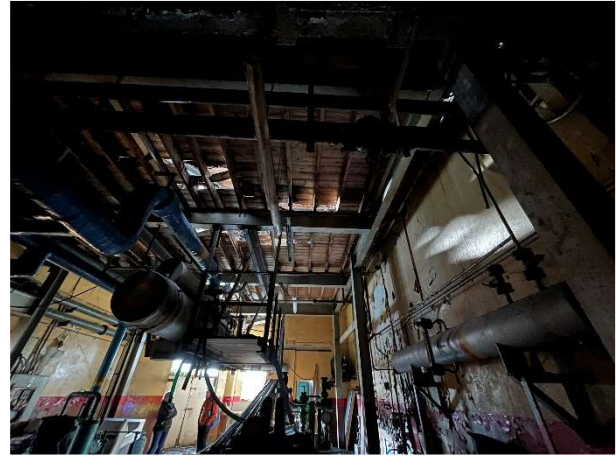
Ground floor level showing first floor structure

The first floor has some very obvious holes where water has come in through the flat roof. The main steel frame supporting the floor, however, appears to be in good condition so renewal of floor joists locally is all that would be required. Elsewhere the older parts of the first floor appear to be concrete filler joist or concrete spanning between downstand steels. Generally these areas are in much worse condition and their structural integrity would need to be carefully checked at the next stage.

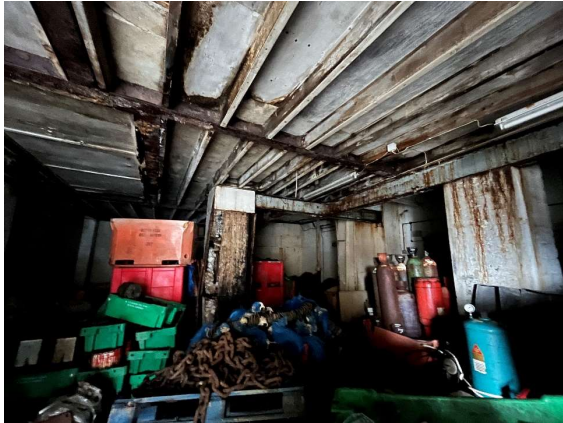
March 2022

The southern section is starting to more rapidly deteriorate now. The hole in the main roof has enlarged and the timber first floor structure below should not be walked on.

In terms of future use, at present it is still highly likely that the original structure could largely be re-used with brushing back and repainting of steel structures and re-use or replacement of the timbers. Comparing photographs, at present the deterioration is gently increasing, however, if the building is not secured within the next couple of years there is a chance that at least some parts of the structure will be lost and, along with it, the memory of the building use. The floor structures are entirely dictated by the ice making process. If that is lost there

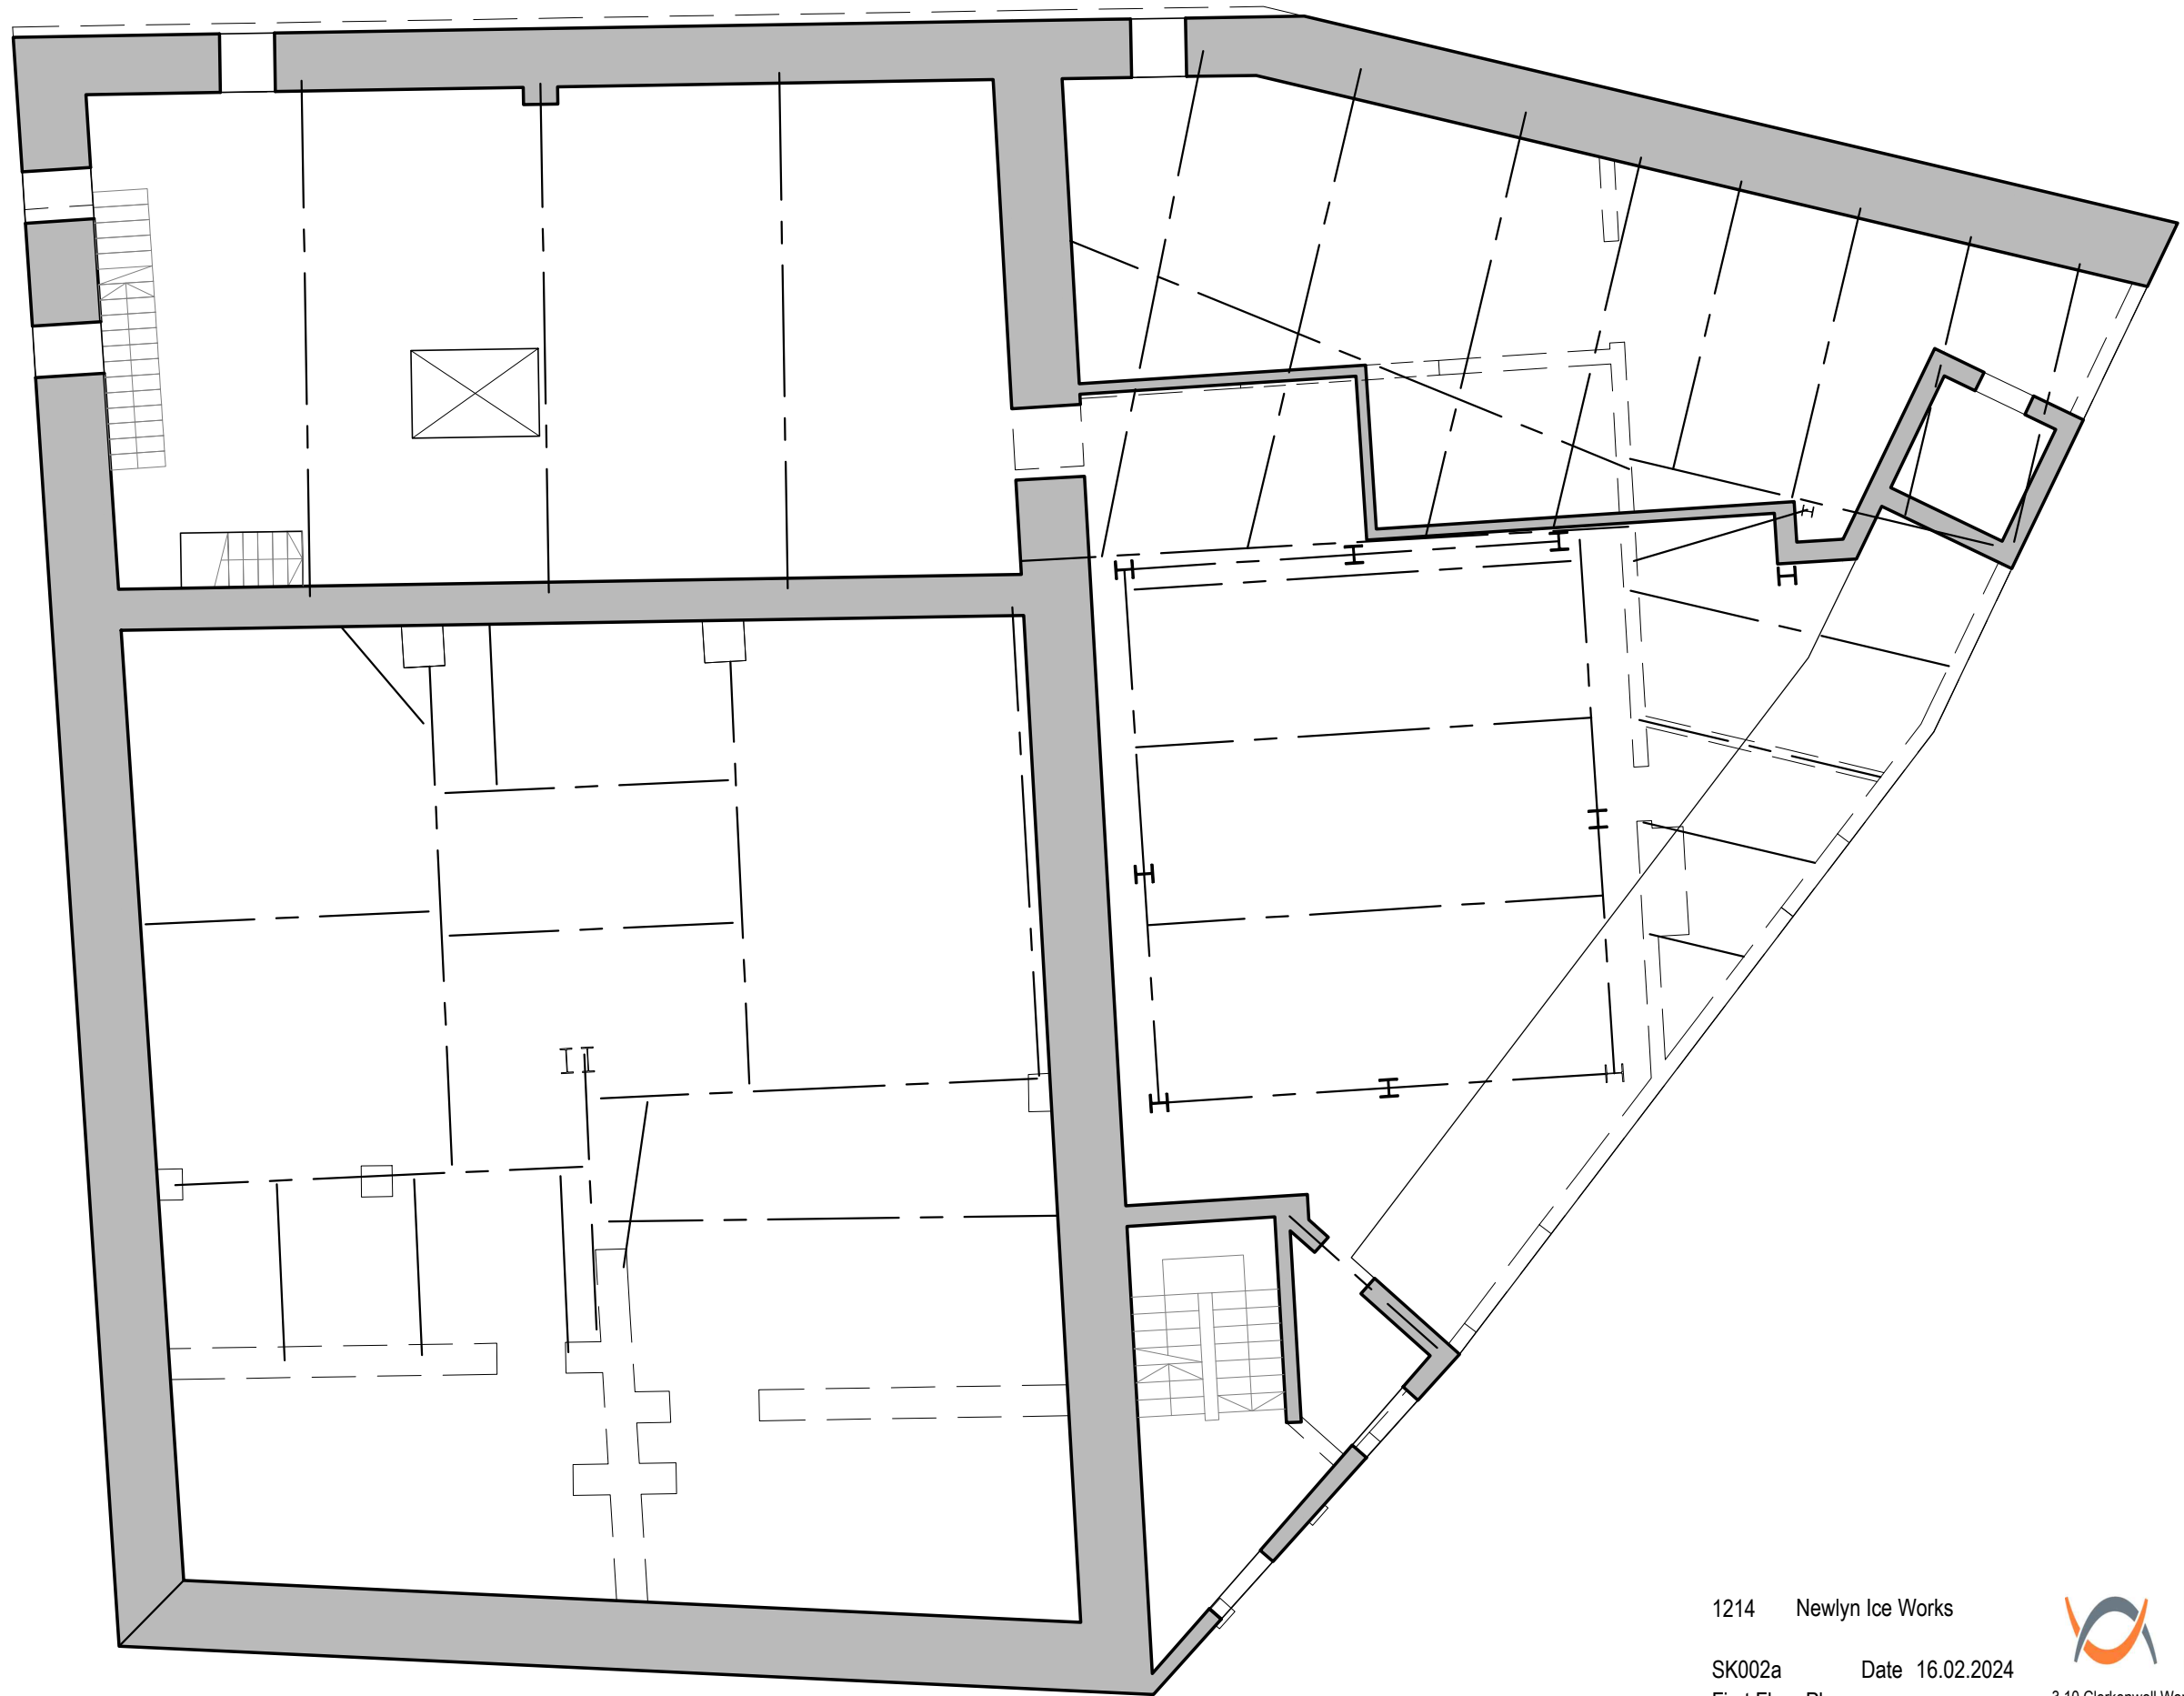
SK002a Date 16.02.2024  
First Floor Plan

The west end of the first floor is in rather poor condition. It is extremely wet, potentially as a result of the enormous amount of water which remains in the building even though its industrial use ceased over a decade ago. The steel beams which support the timber floor appear to be heavily corroded. The residual section may prove sufficient to support a new use, however this will need to be carefully assessed at the next stage. One column in the space is very heavily corroded and this

may be indicative of corrosion elsewhere. The timber joists are heavily water damaged, though again they may have sufficient residual strength to be reused.

The east end of the first floor appears to be in better condition. Again the structure is steel or wrought iron beams supporting timber joists but the use in this space appears to have been much drier so the steelwork and the joists are not heavily corroded and water stained as they are elsewhere.

- 6.3 The southern building and the eastern end of the northern building appear to be in poor but salvageable condition. Water ingress has resulted in deterioration of joists and corrosion of the steelwork. This will need to be assessed in detail at the next stage with intrusive investigation to establish the extent of corrosion and rot and the residual section. The building was designed to carry heavy industrial loads, however, so even fairly extensive loss of section may still provide sufficient capacity for a range of new uses. In a cost plan one should assume fairly extensive local repairs to timber and comprehensive cleaning back and repainting of steelwork.
